NASA Contractor Report 165928

AIRCRAFT SURFACE COATINGS

ENERGY EFFICIENT TRANSPORT PROGRAM

Contract NAS1-15325, Task 4.4

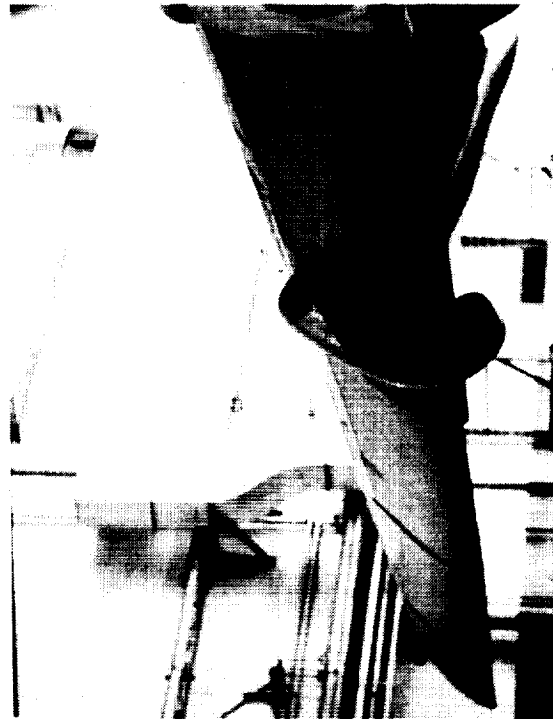
(b) Slots 5, 6, 7, and 8 (Chemglaze)

The Chemglaze-coated slats (slats 5, 6, 7, and 8), with the exception of slat 5, shown at 1200 hours in Figure 22, had peeled at both ends and showed some surface crazing near the inboard end. Slat 5 was stripped and recoated at 1539 hours and was in relatively good condition for the remainder of the evaluation.

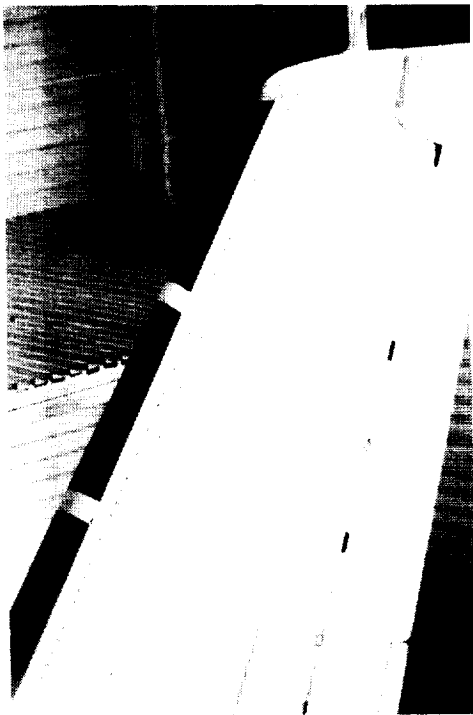
(c) Slots 5, (c) Left Horizontal Tail Leading Edge (CAAPCO)

The three CAAPCO-coated panels (items 9, 10, and 11) on the left outboard horizontal tail experienced early edge peeling at the inboard ends that extended about 1.2 to 2.5 cm (0.5 to 1 in) into the coated leading edge. Figure 23 shows this condition at the inboard end of item 9 after 2092 flight-hours. Shortly thereafter (at 2160 hours), touchup repair of these areas was attempted and, after a cure time of about 40 hours, the airplane returned to flight status. The next field inspection, at 2290 flight-hours, revealed that the repairs were not properly accomplished and peeling recurred, as shown in Figure 24. The touchup repairs on items 1, 9, 10, and 11 required 5 labor-hours to complete.

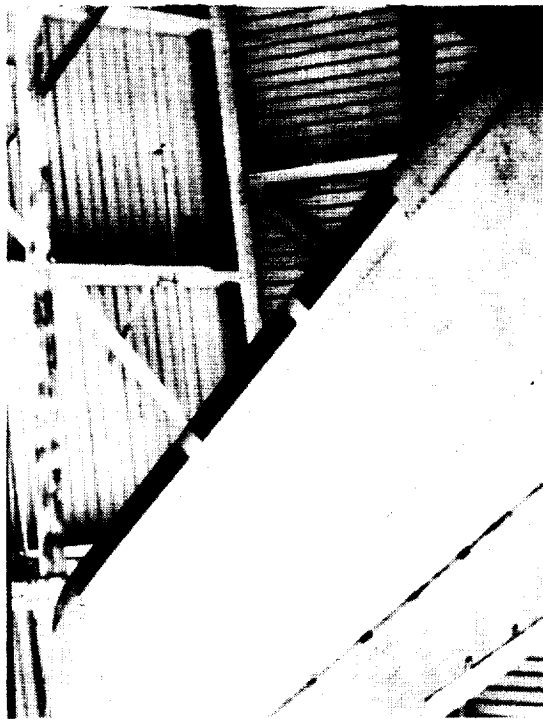
(d) Right Horizontal Tail Leading Edge (Control Part)

1979 when the airplane was flying U.S. domestic routes. In October 1980, this airplane was transferred to the Air Micronesia system and was destroyed in an accident 1 month later. The right outboard horizontal tail leading edge, which had been coated in the laboratory with the three test coatings and which had been serving as a control part, was removed intact and installed on another Air Micronesia 727 until October 1981. Results of the second CO evaluation, emphasizing results on the control part, are reported in the following paragraphs.

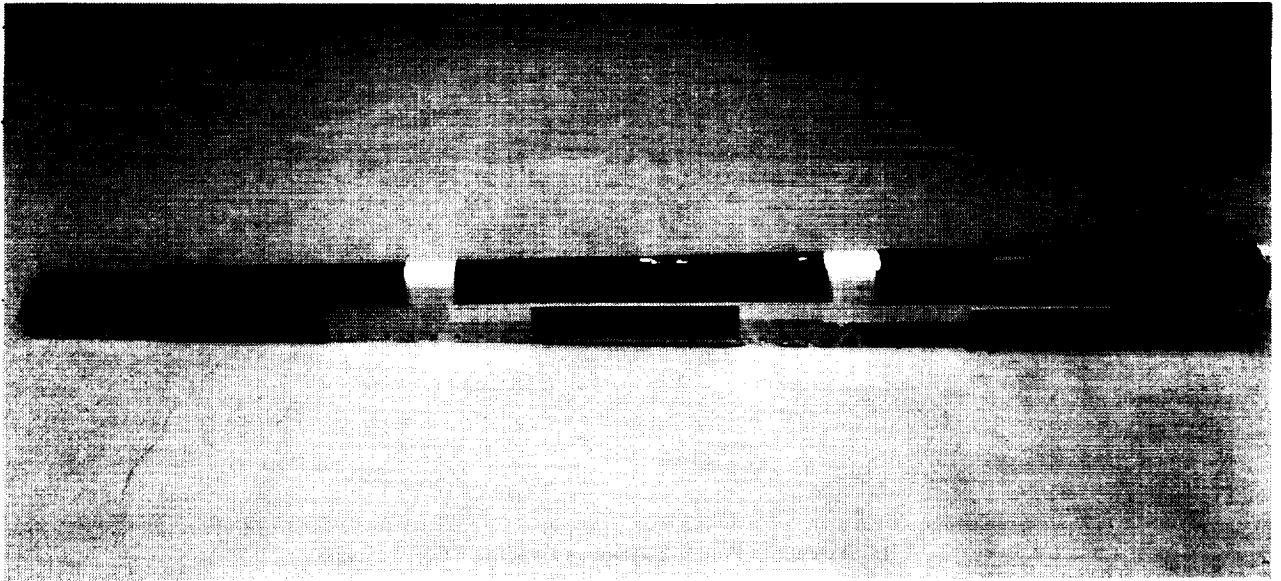
The control part was inspected at Guam after 3815 flight-hours (fig. 26a). Chemglaze, on the outboard panel, and CAAPCO, on the inboard panel, were in good condition. The Astrocoat center panel, (fig. 26b) had three small spots on the leading edge where the coating had eroded down to bare metal.

(b) Astrocoat Center Panel—Three Small Erosion Spots on Leading Edge
Figure 26. Laboratory-Applied Coatings on Control Part (3815 hr)

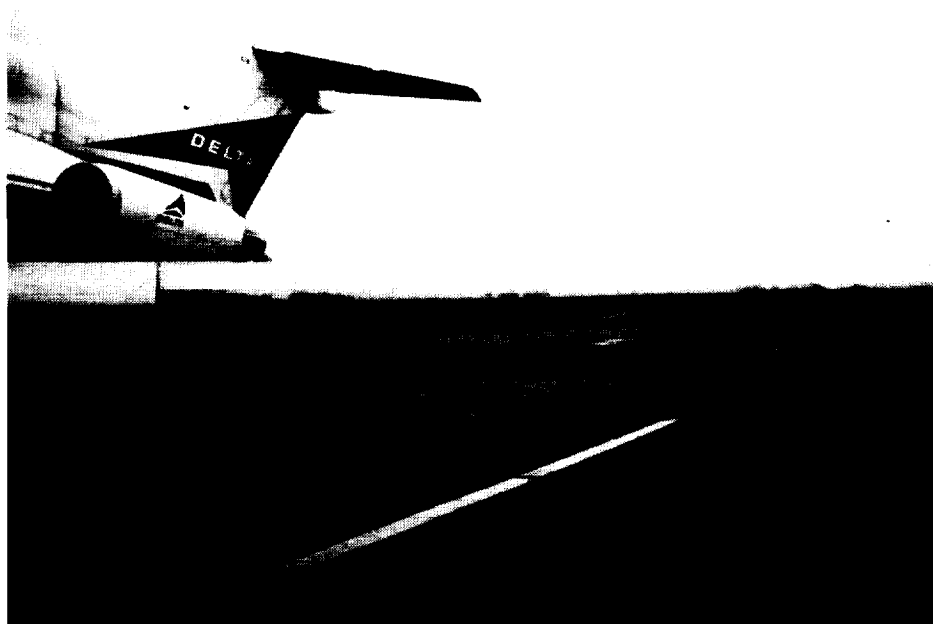
Slats 2 and 3, coated with Chemglaze M413, began to lose gloss after about 600 flight-hours and began to yellow from UV exposure after about 2400 hours. At the 2901-hour inspection, erosion down to the primer had occurred on the slat 2 leading edge. Leading-edge erosion began on slat 3 shortly after that inspection. Slat 3 erosion at 4348 flight-hours is shown in Figures 31a and 31b. The dark patches along the leading edge are areas where primer is exposed.

(a) Leading-Edge Erosion

Figure 31. Slat 3 at 4348 hr—Chemglaze Over Epoxy Primer

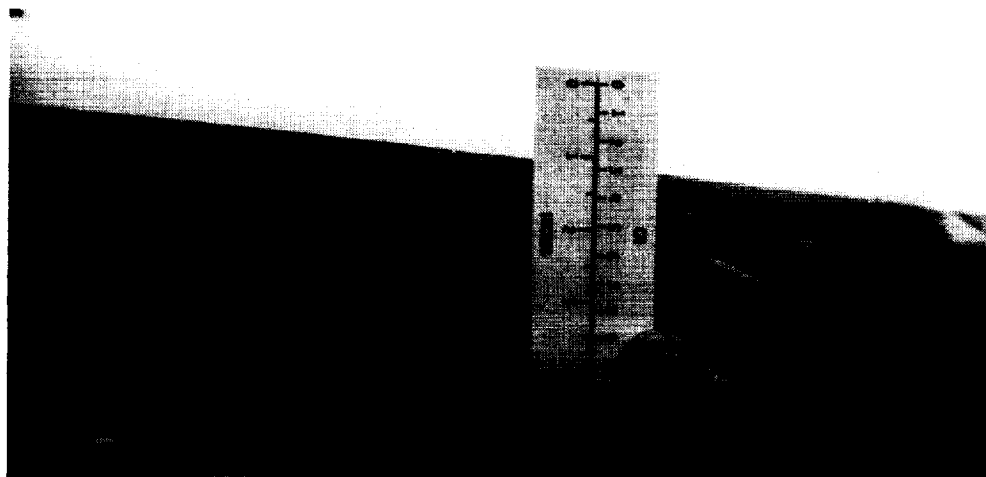
Coating erosion on slat 2 (fig. 32a) and slat 3 (fig. 32b) had become quite prevalent at 6435 flight-hours. Bare metal was exposed over much of the leading-edge span, typical of that shown in Figure 32c. The Chemglaze adhered well to the epoxy primer. There was no peeling on either slats 2 or 3. A UV protective coating over Chemglaze M413 probably would have increased its erosion life significantly by delaying and/or reducing deterioration caused by UV radiation.

(c) Bare Metal Exposed on Slat 3 Leading Edge

Figure 32. Chemglaze Coating Over Epoxy Primer (6435 hr)

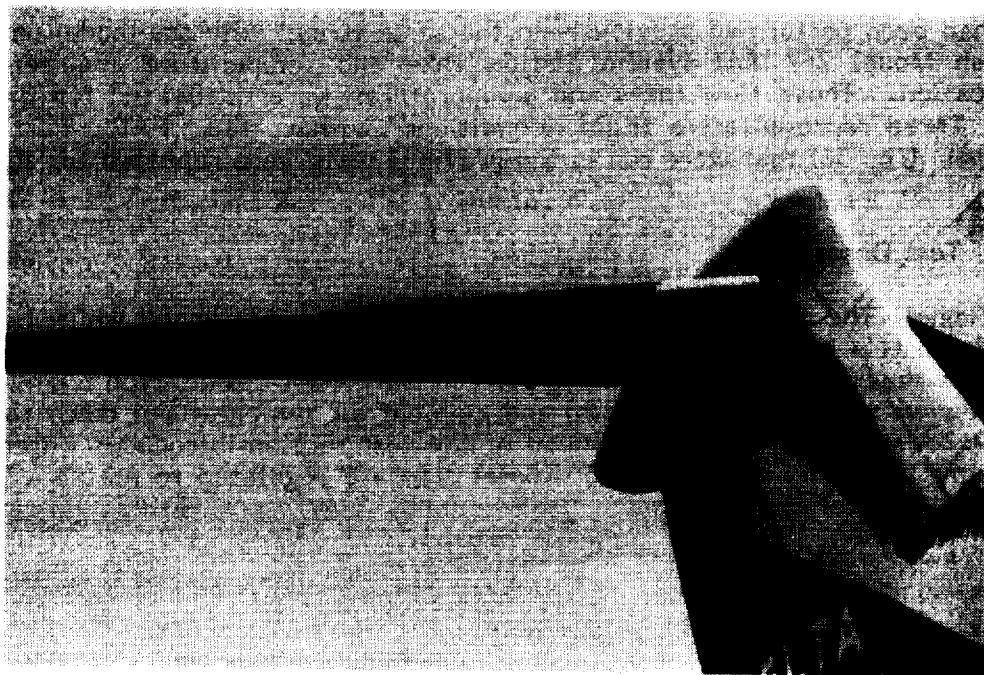
12	Chemglaze M313	OK	OK	OK	Slight erosion developing at inboard end	No change	No change	Losing gloss	No change	No change		Two peeled spots on leading edge approximately 2.54-cm (1-in) diameter inboard end eroded 5.1 cm (2 in) (fig. 35)
13	Bare											Slight leading-edge erosion
14	CAAPCO B-274	OK	Coating removed at approximately 500 hr because of excessive peeling

The right horizontal tail leading edge is shown at 6435 hours in Figure 35. The inboard panel, coated with Chemglaze, had erosion at the inboard end that grew to about 5 cm (2 in) by the end of the evaluation. Also, there were two peeled spots on the leading edge about 2.54 cm (1 in) in diameter. The outboard panel began losing CAAPCO coating very early, and the coating had to be removed at about 500 hours.

Figure 35. Inboard Panel at 6435 hr—Erosion at Inboard End
